EXECUTIVE SUMMARY

NORESKO is pleased to present to Illinois State University this comprehensive Investment Grade Audit (IGA) for an Energy Performance Contracting Program. The primary purpose of conducting this audit per the Energy Audit Agreement (EAA) is to:

The primary scope of this audit includes improvements at Milner Library, Science Lab Building, Heating Plant and their associated Chilled Water Systems. Based on the criteria set forth by the University, the final project must self fund in aggregate in 20 years or less and each ECM must either save energy or improve the infrastructure or both while enhancing the learning environment on campus.

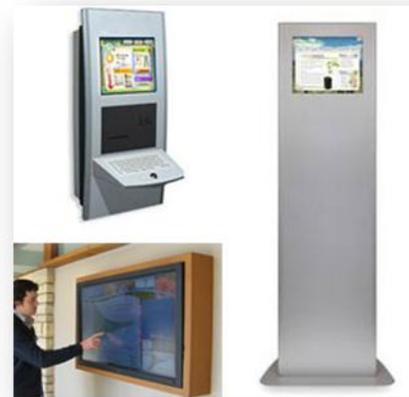
NORESCO has designed a custom program in the list of ECMs that includes the installation of an interactive monitor located at the Bone Student Center that will display real time energy usage for the Library and Science Lab while describing the Performance Contracting initiatives. Also, the monitor will display a graphic depiction of numerous “green” initiatives throughout campus to help educate and create a

culture of energy conservation and social responsibility at Illinois State. NORESKO is working to include the design and installation of this initiative as a capstone class within the Renewable Energy Department to help maximize the learning opportunity of this initiative.
